POSITION-DEPENDENT DISC HERNIATION AND ASSOCIATED SPINAL INSTABILITY

UNOPERATED HYPERMOBILE INTERSEGMENTAL SPINAL INSTABILITY

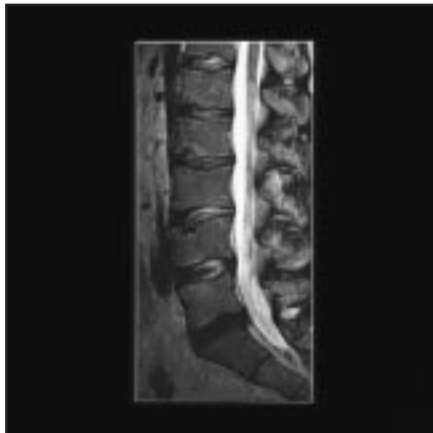
34A - Recumbent

The recumbent image (34A) shows degenerative disc disease at L5/S1 and an associated minor disc bulge at this level. The upright image (34B) reveals further narrowing of the disc space and a focal posterior disc herniation (arrow) at L5/S1. In addition, associated minor degenerative intersegmental hypermobile instability (retrolisthesis) is present at this same level in the upright position.

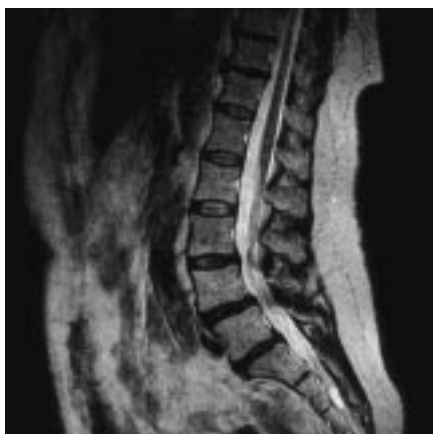
28A - Recumbent

The recumbent image (28A) shows degenerative disc disease at L4/5 and L5/S1. The upright image (28B) reveals degenerative intersegmental hypermobile instability (anterolisthesis: arrow) at the L4/5 level. The L4/5 and L5/S1 levels show further narrowing of the disc spaces in the upright position.
